05 - STRUCTURES INDEX OF DRAWINGS

SUBSTRUCTURE CONCRETE REPAIRS IN DISTRICT 2

SUBSET COVER SHEET INDEX OF DRAWINGS-1

172-417
DRAWING NO.
S-01

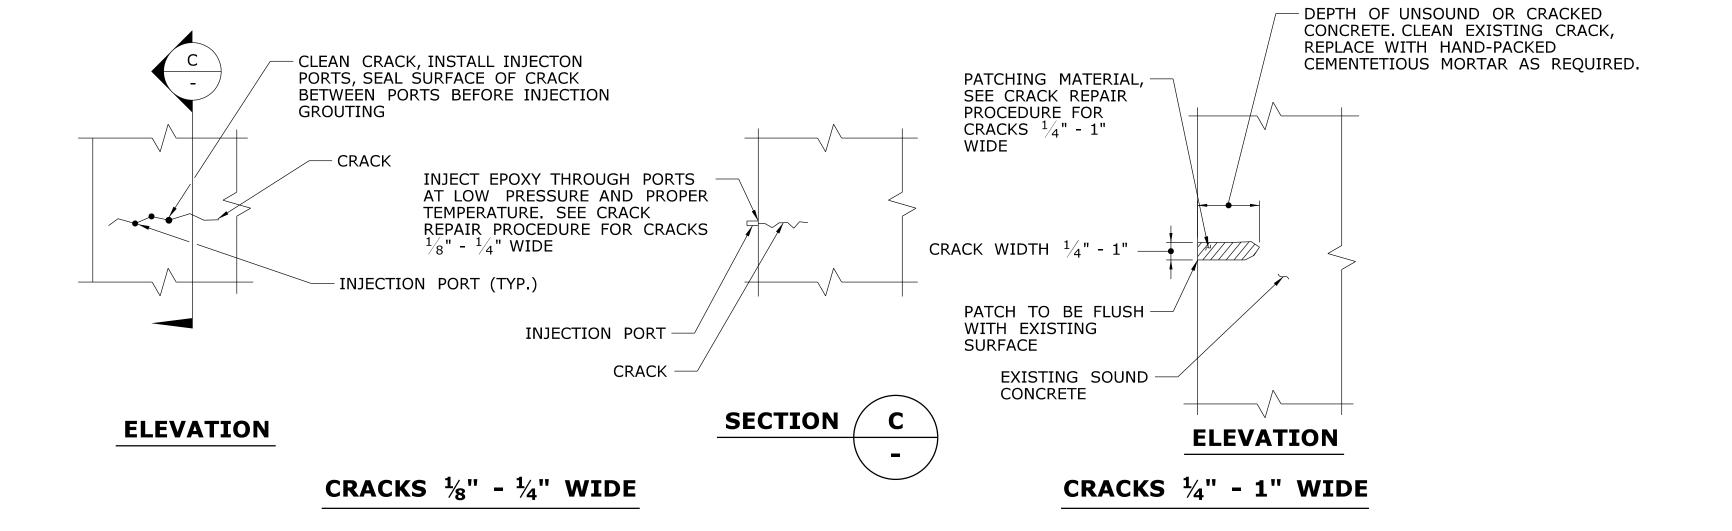
CRACK REPAIR DETAIL

- MIX EPOXY GROUT PER MANUFACTURER'S SPECIFICATION. - WHEN THE EPOXY ADHESIVE HAS CURED, INJECT THE EPOXY GROUT WITH STEADY PRESSURE.

- ALLOW THE INJECTED EPOXY GROUT TO SET THEN CUT THE PRESSURE
- INJECTION PORTS FLUSH WITH THE EPOXY ADHESIVE.
- 3. CRACK REPAIRS SHALL BE PAID FOR UNDER THE ITEM "EPOXY INJECTION CRACK REPAIR". SEE SPECIAL PROVISIONS.
- 4. ANY CRACK LESS THAN $\frac{1}{8}$ " SHALL NOT BE REPAIRED UNLESS DIRECTED BY THE ENGINEER.

CRACK REPAIR PROCEDURE FOR CRACKS $\frac{1}{4}$ " - 1" WIDE

- MIX COMPONENTS OF PATCHING MORTAR AND EPOXY ADHESIVE IN
- ACCORDANCE TO THE MANUFACTURER'S SPECIFICATIONS.
- APPLY EPOXY ADHESIVE ONTO THE CONCRETE WITH A BRUSH OR BROOM - APPLY THE PATCHING MORTAR WHILE THE EPOXY ADHESIVE IS STILL TACKY. IF THE COATING BECOMES GLOSSY AND LOOSES TACKINESS,

- REMOVE ANY SURFACE CONTAMINANTS AND RECOAT WITH ADDITIONAL ADHESIVE EPOXY AND PROCEED WITH PATCHING WORK. - SCRUB REPAIR MORTAR INTO THE SUBSTRATE, FILLING ALL PORES AND VOIDS.

- FORCE MATERIAL AGAINST EDGE OF REPAIR, WORKING TOWARDS THE CENTER.
- MATERIAL MAY BE APPLIED IN MULTIPLE LIFTS. EACH LIFT THICKNESS SHALL
- NOT BE LESS THAN $\frac{1}{8}$ " NOR GREATER THAN 3" THICK. - WHERE MULTIPLE LIFTS ARE REQUIRED, SCORE TOP SURFACE OF EACH LIFT TO

- AFTER FILLING REPAIR, CONSOLIDATE, THEN SCREED.
- ALLOW MORTAR TO SET TO DESIRED STIFFNESS, THEN FINISH WITH WOOD
- OR SPONGE FLOAT FOR A SMOOTH SURFACE.

- 3. CURING: - CURING SHOULD COMMENCE IMMEDIATELY AFTER FINISHING.
- IF NECESSARY, PROTECT NEWLY APPLIED MATERIAL FROM DIRECT SUNLIGHT,
- WIND, RAIN OR FROST. - MOIST CURE WITH FINE MIST OF WATER OR WITH WET BURLAP AND POLYETHYLENE.

- 4. CRACK REPAIR INCLUDING THE COST OF CEMENTITIOUS MORTAR SHALL BE PAID UNDER THE ITEM "EPOXY INJECTION CRACK REPAIR". SEE SPECIAL PROVISIONS.
- 5. FOR CRACKS OR GAPS IN CONCRETE SURFACE GREATER THAN 1", USE SHALLOW PATCH REPAIR DETAIL.

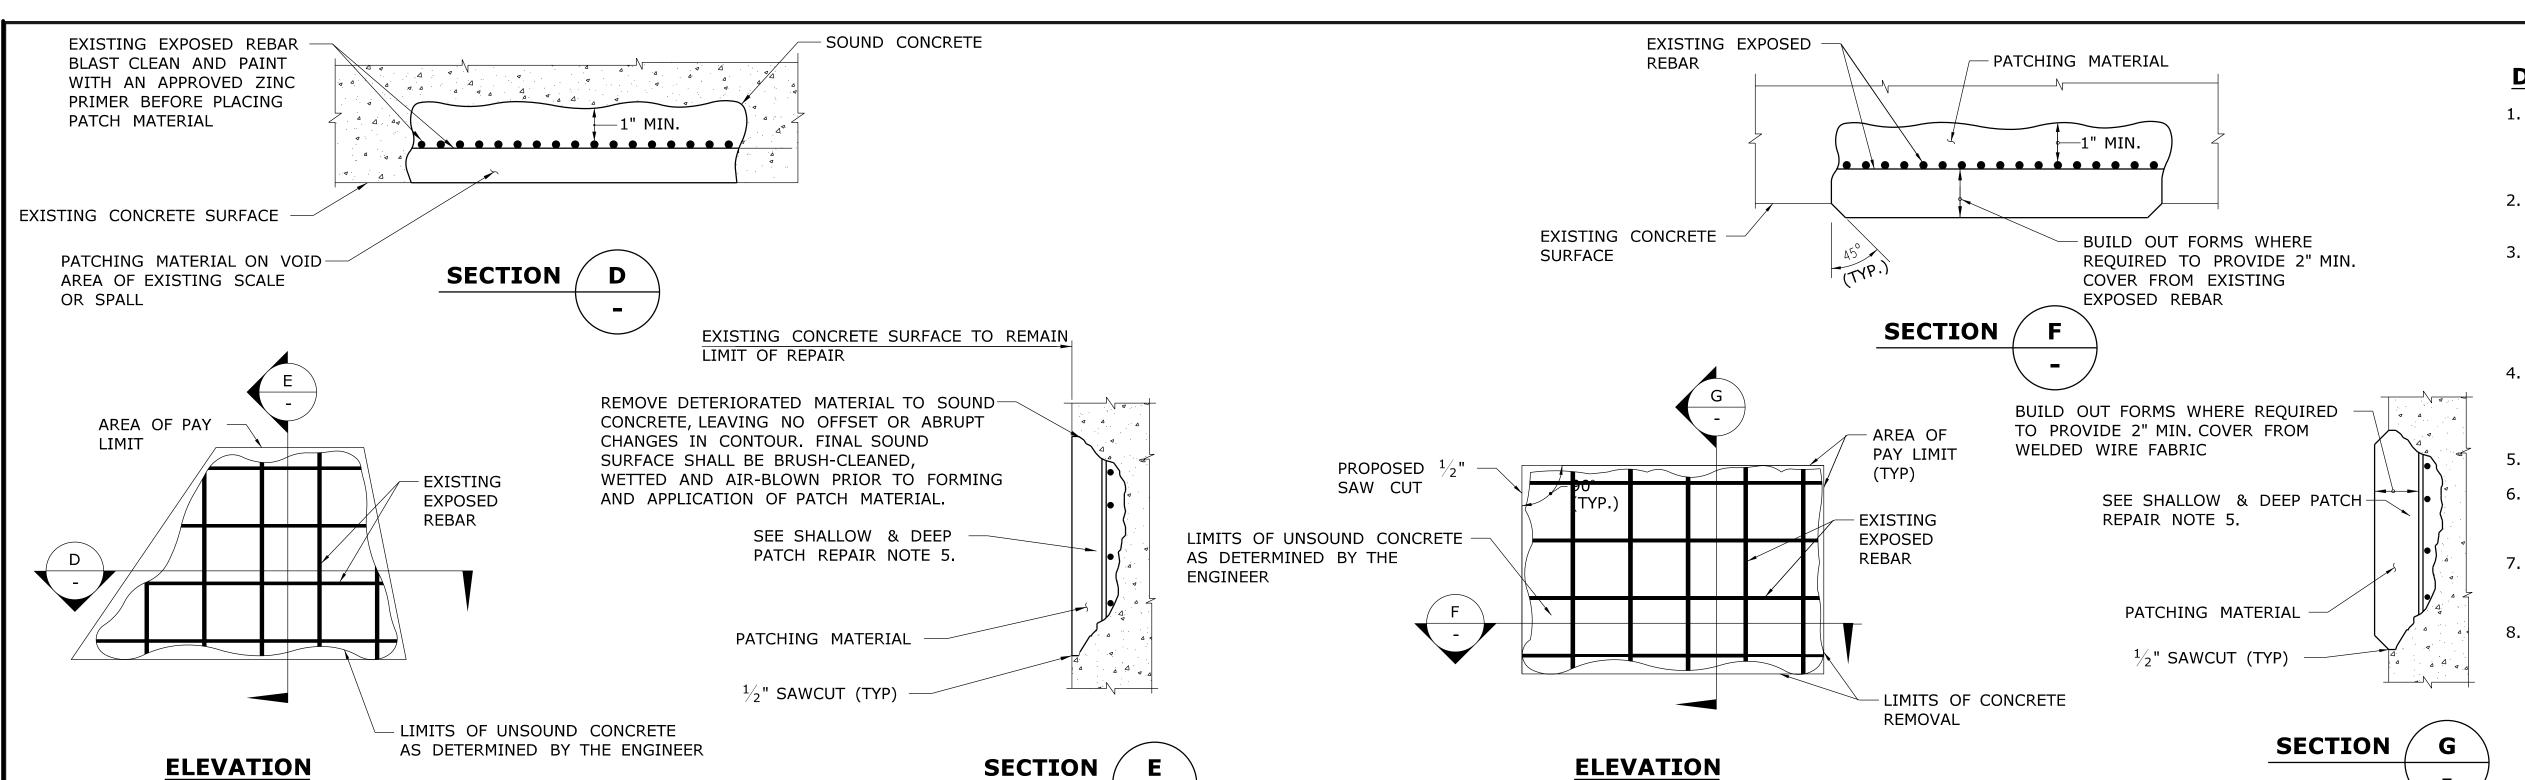
SHALLOW PATCH REPAIR DETAIL NTS

SHALLOW PATCH REPAIR PROCEDURE

- 1. SHALLOW PATCH REPAIR DETAIL APPLIES TO DETERIORATED AREAS WHERE LESS THAN HALF THE CIRCUMFERENCE OF THE EXISTING REINFORCING IS EXPOSED. THESE AREAS SHALL BE REPAIRED WITH VARIABLE DEPTH PATCH.
- 2. REPAIR DEPTH SHALL BE $^{1}\!/_{8}$ "(MIN.) OR GREATER. REPAIR DEPTHS LESS THAN $^{1}\!/_{8}$ " NEED NOT BE REPAIRED.
- 3. FOR AREAS WHERE THE CONCRETE REPAIR EXCEEDS 4"
 IN DEPTH, A SINGLE LAYER OF WIRE MESH SHALL BE
 USED TO REINFORCE EACH 2" THICKNESS OF PATCHING
 MATERIAL. THE COST OF WELDED WIRE FABRIC SHALL
 BE INCLUDED IN THE COST OF PATCHING MATERIAL.
- 4. THE PERIMETER OF EACH DETERIORATED AREA SHALL BE SQUARED-OFF BY SAWCUTTING.
- 5. SURFACE PREPARATION

SHALLOW AND DEEP PATCH REPAIR NOTES

- 1. ALL WORK SHOWN ON THIS DRAWING SHALL BE PERFORMED WHERE DIRECTED BY THE ENGINEER.
- 2. DEEP PATCH REPAIRS SHALL BE PAID ITEM CLASS "S" CONCRETE. SHALLOW PATCH REPAIRS SHALL BE PAID UNDER ITEM "VARIABLE DEPTH PATCH". SEE SPECIAL PROVISIONS.

- 3. SURFACE PREPARATION, PROPORTIONING AND MIXING OF MATERIALS, APPLICATION OF MATERIALS AND REPAIR PROCEDURES SHALL BE IN ACCORDANCE WITH THE MANUFACTURER'S RECOMMENDATIONS.

- 3. THE CONTRACTOR SHALL NOT PERFORM ANY REPAIR WORK WITHOUT PRIOR APPROVAL FROM THE ENGINEER.
- 4. SPALLS, HOLLOW AND SCALE AREAS SHALL BE REPAIRED IN ACCORDANCE WITH "SHALLOW PATCH REPAIR DETAIL" OR "DEEP PATCH REPAIR DETAIL" SHOWN ON DWG. NO. S-05.

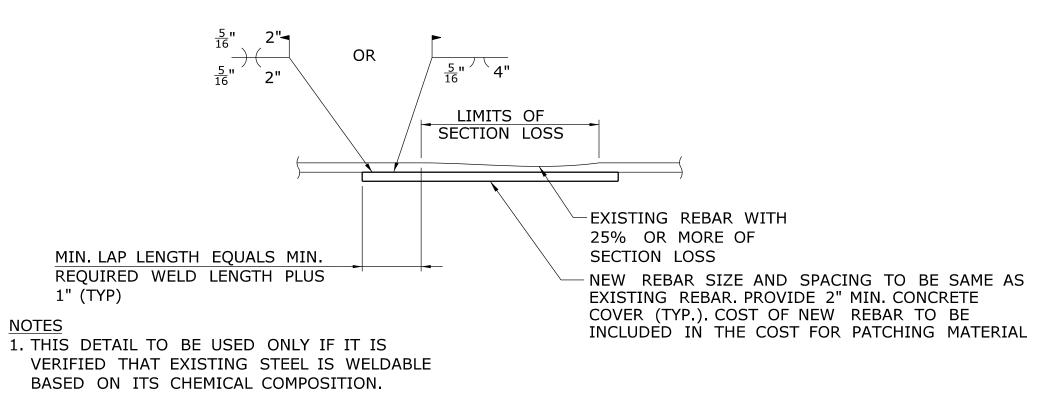
REINFORCEMENT SPLICE DETAIL

LIMITS OF SECTION LOSS EXISTING REBAR WITH MINIMUM SPLICE 25% OR MORE OF LENGTH=30 BAR DIA THE SECTION LOSS BARS SHALL BE TIED WITH A WIRE TOGETHER FOR THE FULL LENGTH OF THE NEW REBAR SIZE TO BE SAME SPLICE. (TYP. EACH END) AS EXISTING REBAR. PROVIDE 2" MIN. CONCRETE COVER (TYP.). COST OF NEW REBAR TO BE INCLUDED IN THE COST FOR PATCHING MATERIAL

LAPPED TIED SPLICE BAR

LAPPED WELDED SPLICE BAR

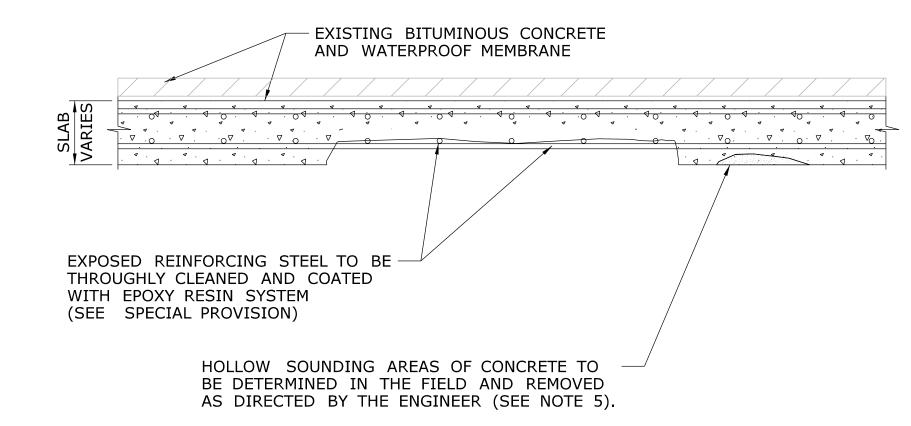
DECK UNDERSIDE REPAIRS (SURFACE PATCH)

DECK UNDERSIDE REPAIR NOTES

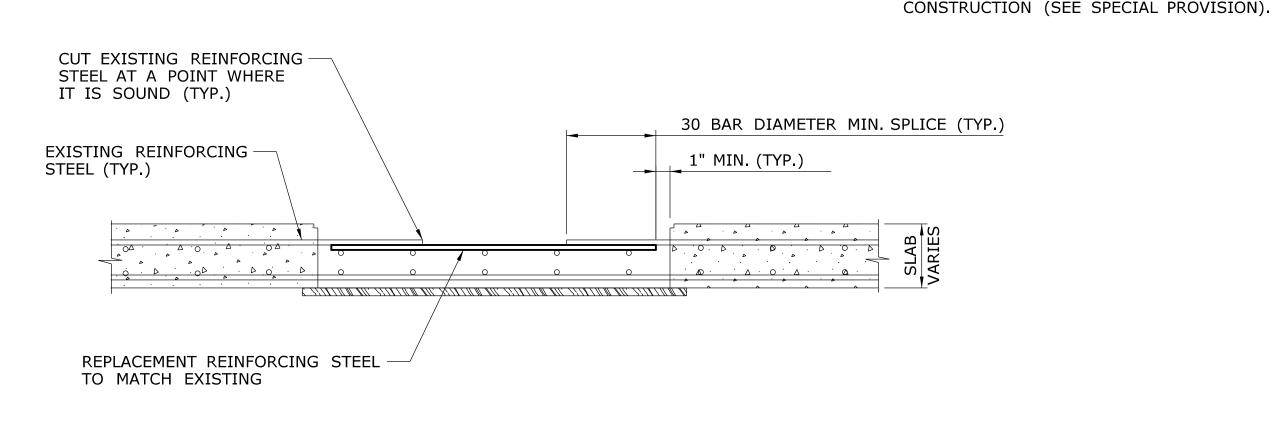
DEFECTIVE REINFORCING STEEL REPAIR DETAIL FOR FULL DEPTH PATCH N.T.S.

EXISTING REINFORCING STEEL SHALL BE THOROUGHLY — CLEANED. REPAIR REINFORCING STEEL IF DETERMINED TO BE DEFECTIVE BY THE ENGINEER. SEE DETAIL AND REMOVE DETERIORATED CONCRETE AND REPLACE WITH -FULL DEPTH PATCHING MATERIAL (SEE "FULL DEPTH PATCH" SPECIAL PROVISION) TOP OF SLAB -FORM SHALL BE SUPPORTED IN A MANNER APPROVED BY THE ENGINEER

FULL DEPTH PATCH REPAIR DETAIL

1. FULL DEPTH PATCH REPAIRS SHALL BE PERFORMED IN ACCORDANCE WITH DETAIL SHOWN

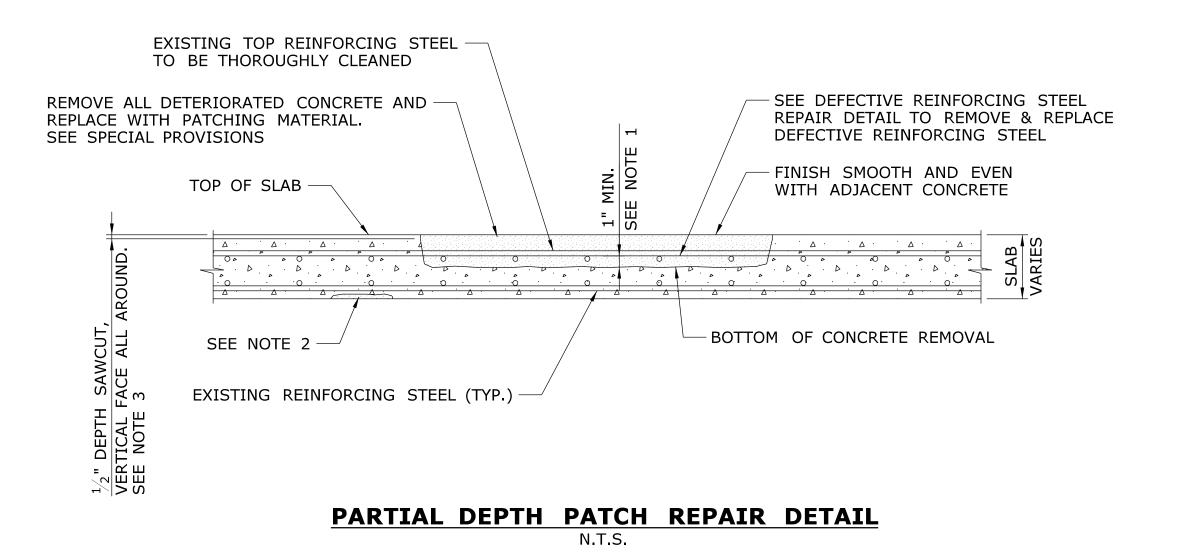
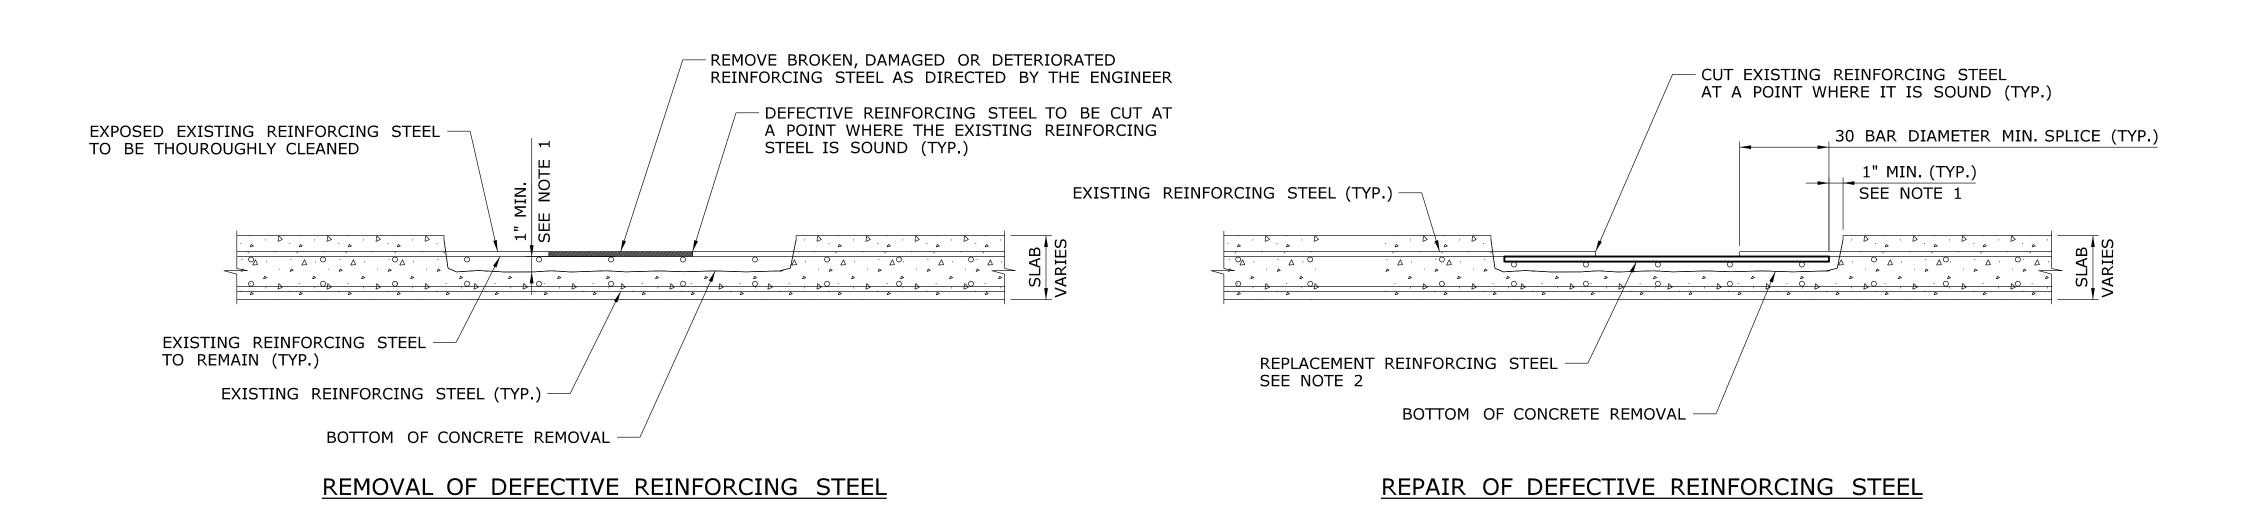
DEFECTIVE REINFORCING STEEL REPAIR DETAIL FOR PARTIAL DEPTH PATCH

PARTIAL DEPTH PATCH REPAIR NOTES

- 1. IF AFTER CONCRETE REMOVAL, THE REINFORCING STEEL HAS AT LEAST ONE HALF OF ITS SURFACE AREA EXPOSED, THE CONCRETE SHALL BE FURTHER REMOVED TO A DEPTH OF 1" BELOW THE STEEL. THE EXPOSED REINFORCING STEEL SHALL BE THOROUGHLY CLEANED TO REMOVE ANY DEBRIS OR RESIDUE BEFORE PLACING "PARTIAL DEPTH PATCHING" MATERIAL.
- 2. EXPOSED REINFORCING STEEL IN THE AREAS OF POP-OUTS CAUSED BY THE REMOVAL OF DETERIORATED CONCRETE SHALL BE CLEANED & THE ENTIRE SURFACE OF THE POP-OUT SHALL BE COATED WITH AN EPOXY COATING.
- 3. COST OF 1/2" DEEP SAWCUT SHALL BE INCLUDED IN THE CONTRACT BID PRICE FOR ITEM "PARTIAL DEPTH PATCH".
- 4. PARTIAL DEPTH PATCH REPAIRS SHALL BE PERFORMED IN ACCORDANCE WITH DETAILS SHOWN ON THIS SHEET AND SHALL BE PAID UNDER THE ITEM "PARTIAL DEPTH PATCH". SEE SPECIAL PROVISIONS.

DEFECTIVE REINFORCING STEEL REPAIR NOTES

- 1. COST OF ADDITIONAL CONCRETE REMOVAL REQUIRED FOR THE REPAIR OF THE REINFORCING STEEL SHALL BE PAID UNDER THE ITEM "PARTIAL DEPTH PATCH".
- 2. NEW REINFORCING STEEL SHALL BE UNCOATED ASTM A615 GRADE 60. FURNISHING AND INSTALLING REINFORCING BARS SHALL BE PAID UNDER THE ITEM "PARTIAL DEPTH PATCH".

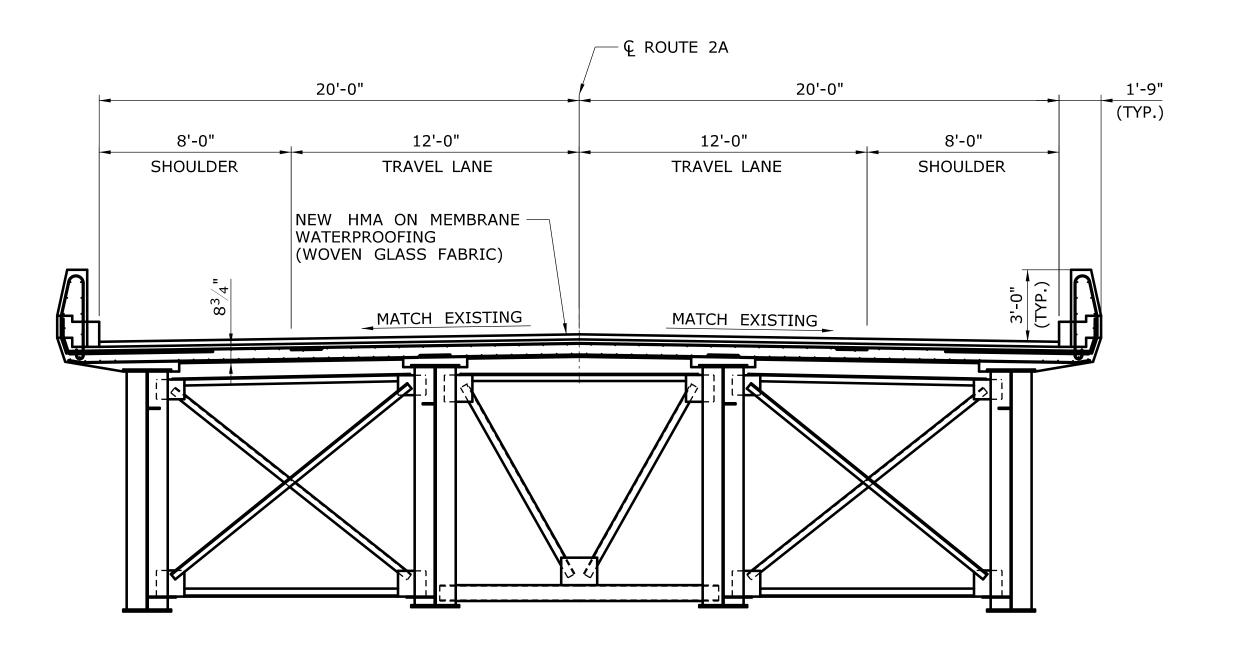
TYPICAL CROSS SECTION

HMA S0.5 TO MATCH THE EXISTING CONDITIONS.

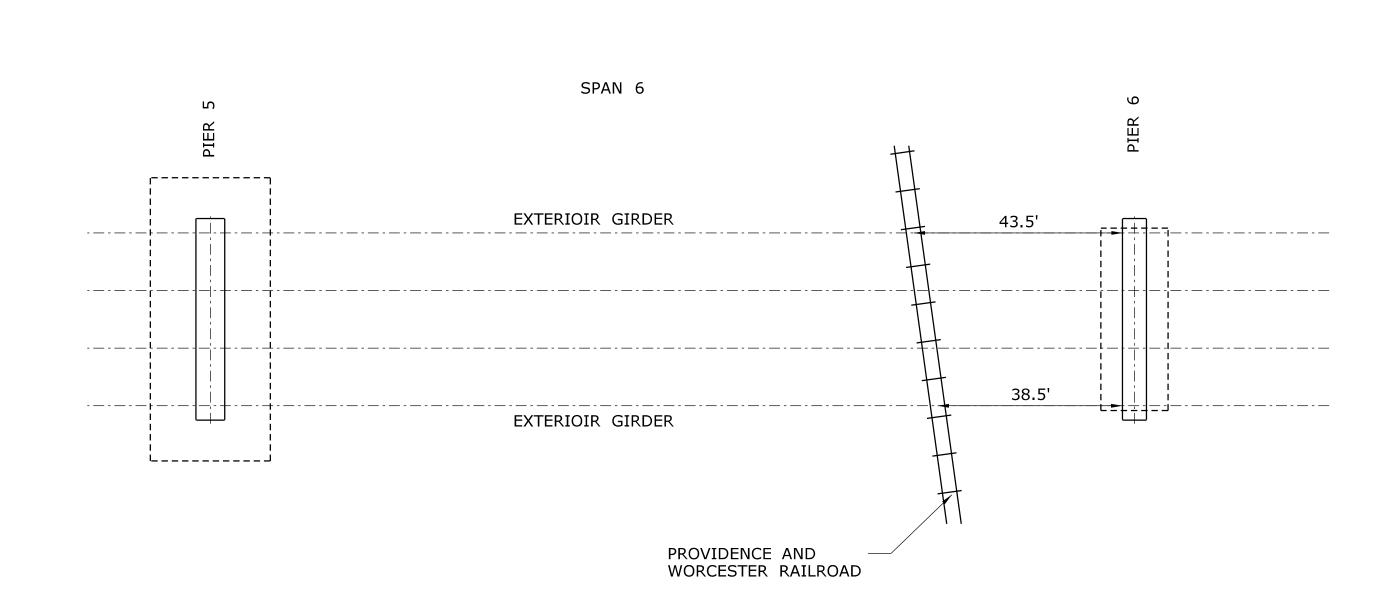
PLAN - SPAN 6 ROUTE 2A OVER P & W RR

RAILROAD CLEARANCE NOTES:

- PRIOR TO STARTING WORK ON THIS BRIDGE SPAN, THE CONTRACTOR SHALL CONTACT NEW ENGLAND CENTRAL RAILROAD TO COORDINATE WORK. SEE "NOTICE TO CONTRACTOR RAILROAD COORDINATION."
- 2. ALL DIMENSIONS TAKEN FROM THE ORIGINAL CONTRACT PLANS AND THE IN-DEPTH INSPECTION REPORTS AND SHALL BE FIELD VERIFIED.

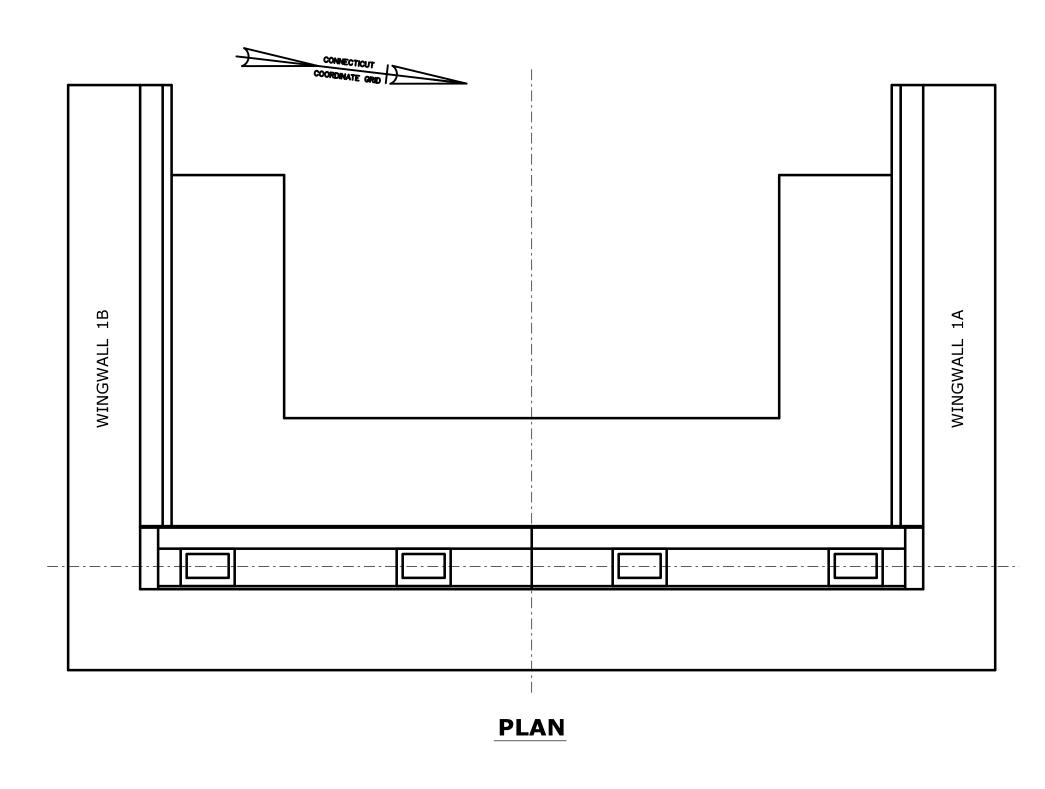
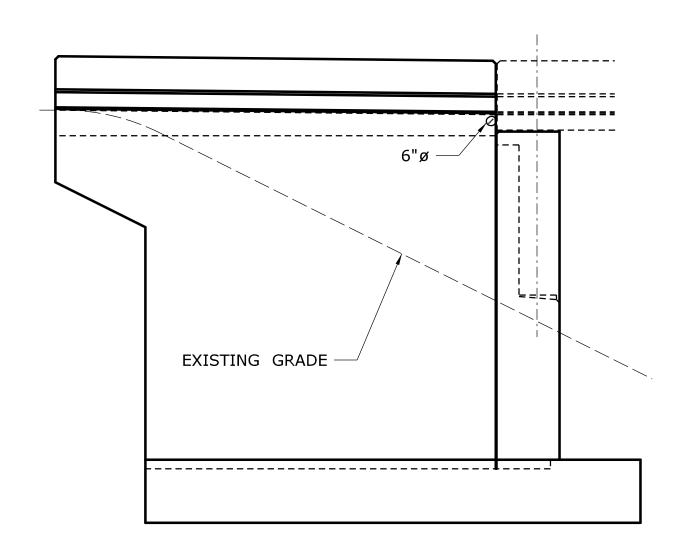
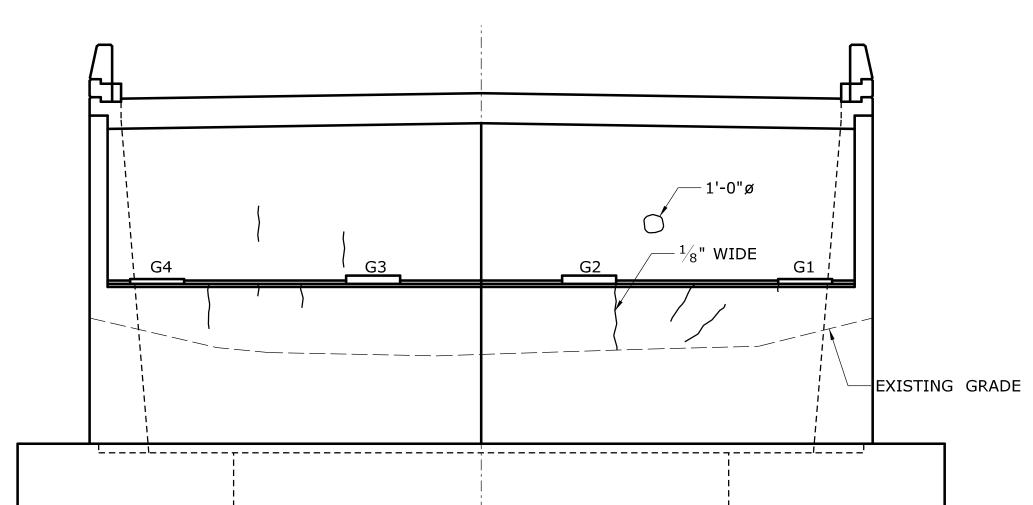
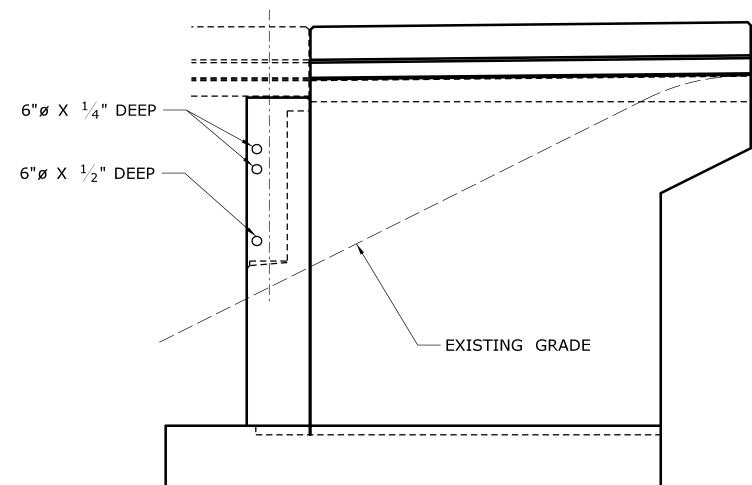
WINGWALL 1B ABUTMENT NO. 1 **WINGWALL 1A**

- 1. THE SUBSTRUCTURE DETERIORATION AND REPAIR DIMENSIONS SHOWN ARE BASED ON LIMITED FIELD OBSERVATIONS AND BRIDGE SAFETY INSPECTION REPORT (11/15/2010). THE INFORMATION IS INTENDED TO BE USED AS A GUIDE AND DOES NOT NECESSARILY REFLECT THE CURRENT CONDITION OF THE STRUCTURE. THE EXACT LOCATION AND LIMITS OF DETERIORATED CONCRETE TO BE REPAIRED SHALL BE DETERMINED BY THE ENGINEER DURING CONSTRUCTION.

- 5. MAXIMUM 15 LB PNEUMATIC HAMMER TO BE USED ADJACENT TO EXISTING REINFORCING TO REMAIN.

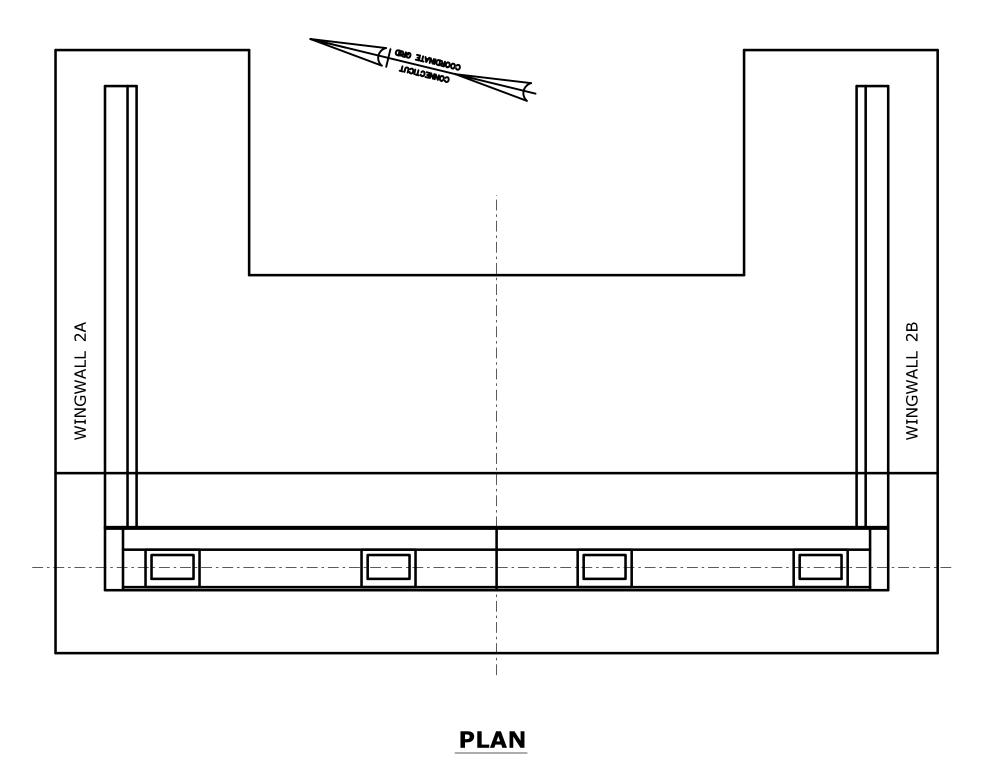
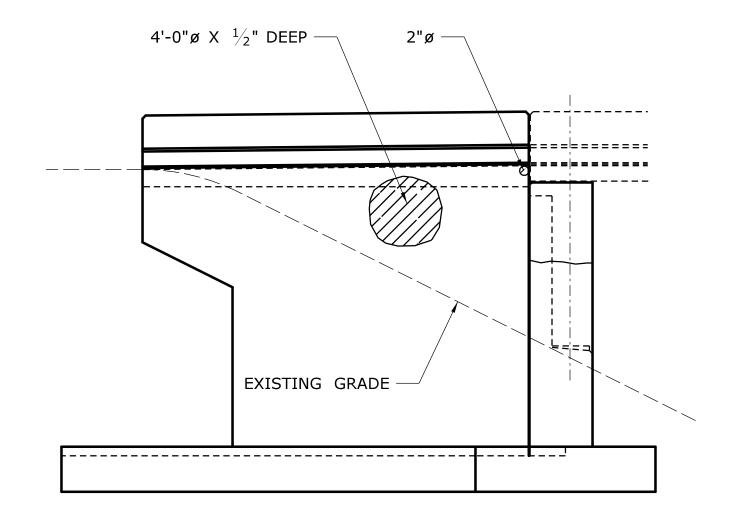
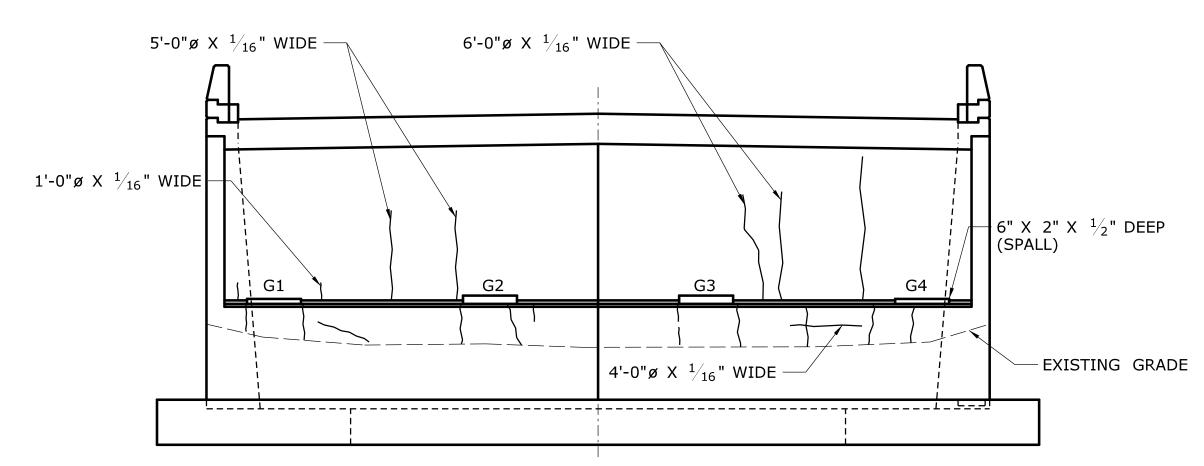
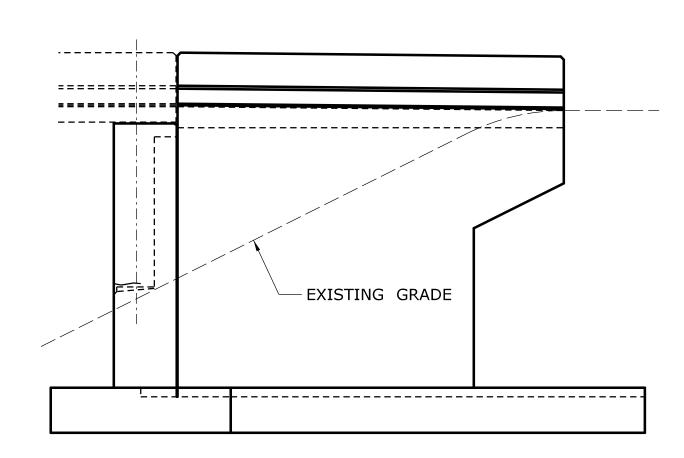
WINGWALL 2A ABUTMENT NO. 2 WINGWALL 2B

- 1. THE SUBSTRUCTURE DETERIORATION AND REPAIR DIMENSIONS SHOWN ARE BASED ON LIMITED FIELD OBSERVATIONS AND BRIDGE SAFETY INSPECTION REPORT (11/15/2010). THE INFORMATION IS INTENDED TO BE USED AS A GUIDE AND DOES NOT NECESSARILY REFLECT THE CURRENT CONDITION OF THE STRUCTURE. THE EXACT LOCATION AND LIMITS OF DETERIORATED CONCRETE TO BE REPAIRED SHALL BE DETERMINED BY THE ENGINEER DURING CONSTRUCTION.

- 3. THE CONTRACTOR SHALL NOT PERFORM ANY REPAIR WORK WITHOUT PRIOR APPROVAL FROM THE ENGINEER.
- 4. SPALLS, HOLLOW AND SCALE AREAS SHALL BE REPAIRED IN ACCORDANCE WITH "SHALLOW PATCH REPAIR DETAIL" OR "DEEP PATCH REPAIR DETAIL" SHOWN ON DWG. NO. S-05.

- 5. MAXIMUM 15 LB PNEUMATIC HAMMER TO BE USED ADJACENT TO EXISTING REINFORCING TO REMAIN.

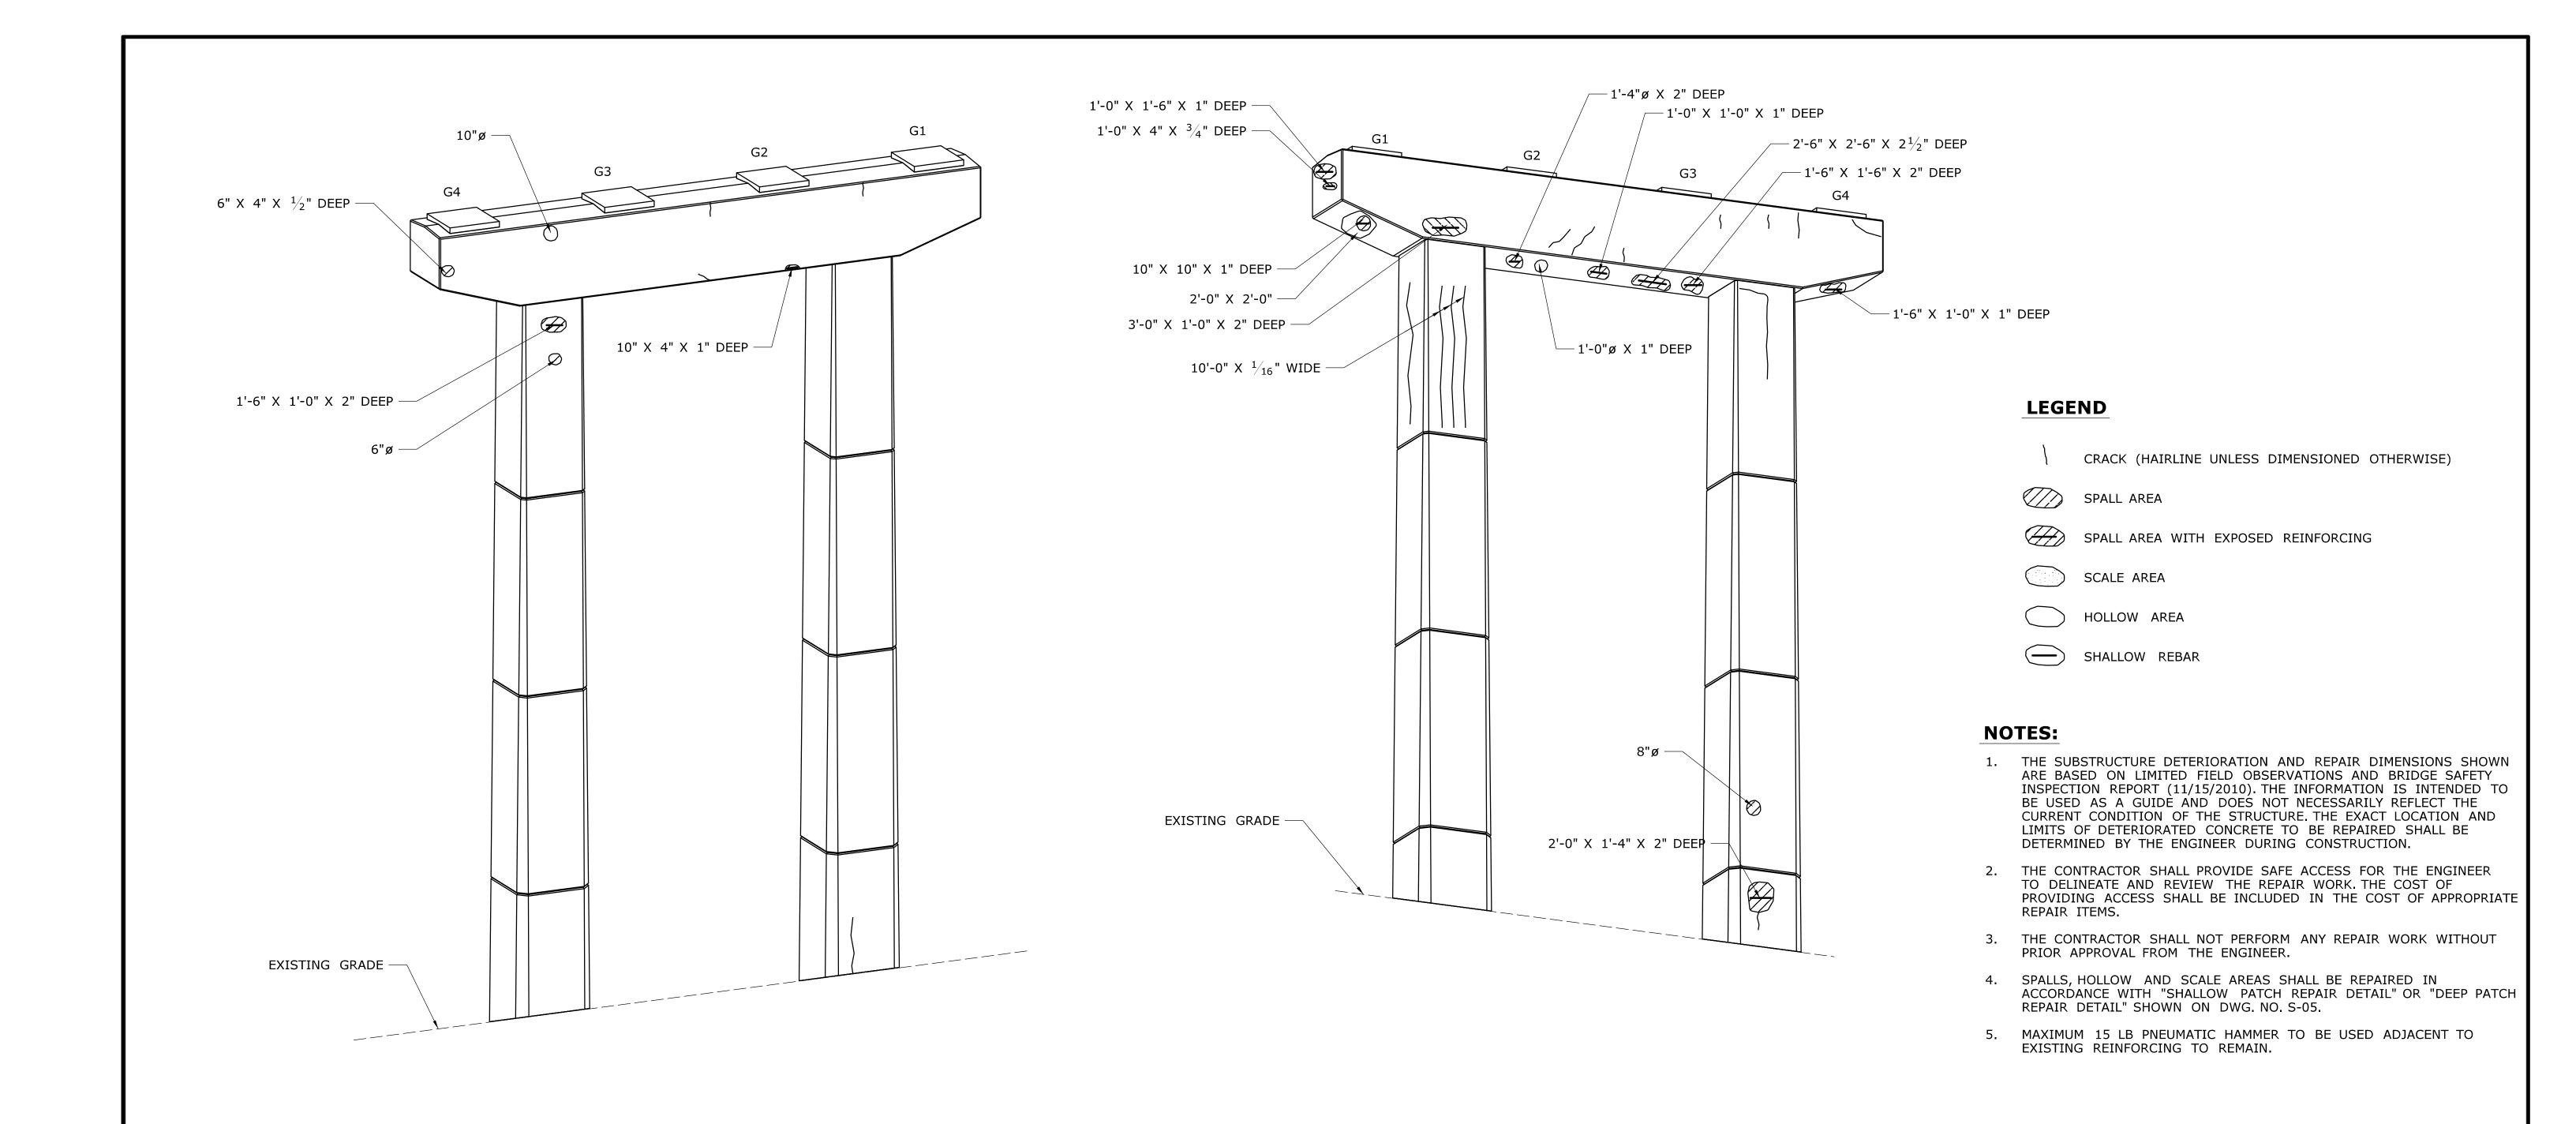
PIER 1 - EAST ELEVATION

PIER 1 - WEST ELEVATION

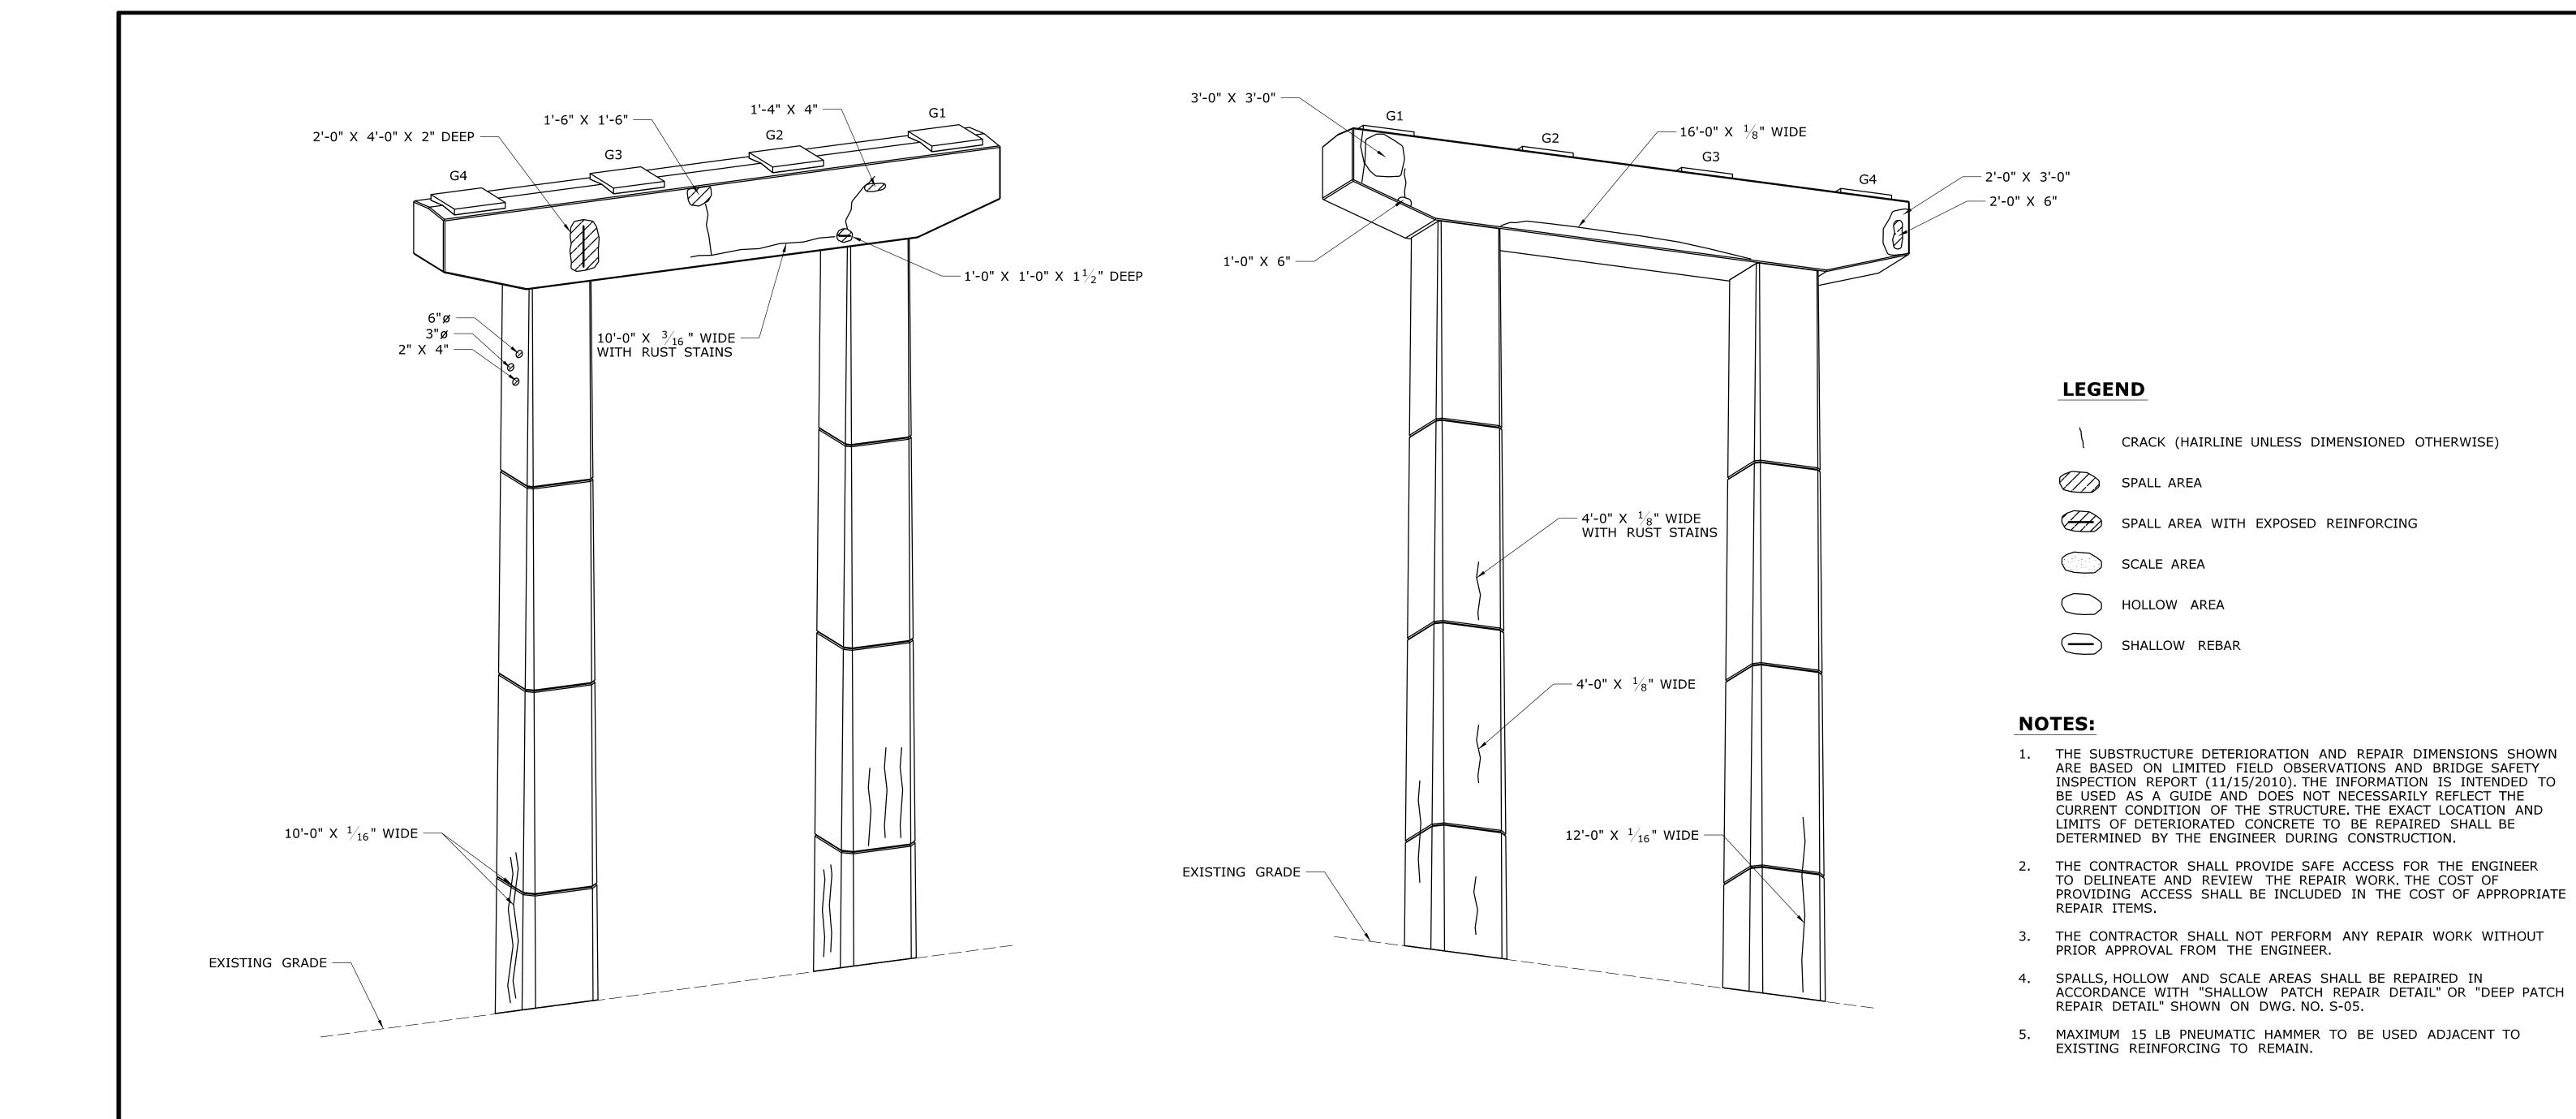
PIER 6 - EAST ELEVATION

PIER 6 - WEST ELEVATION

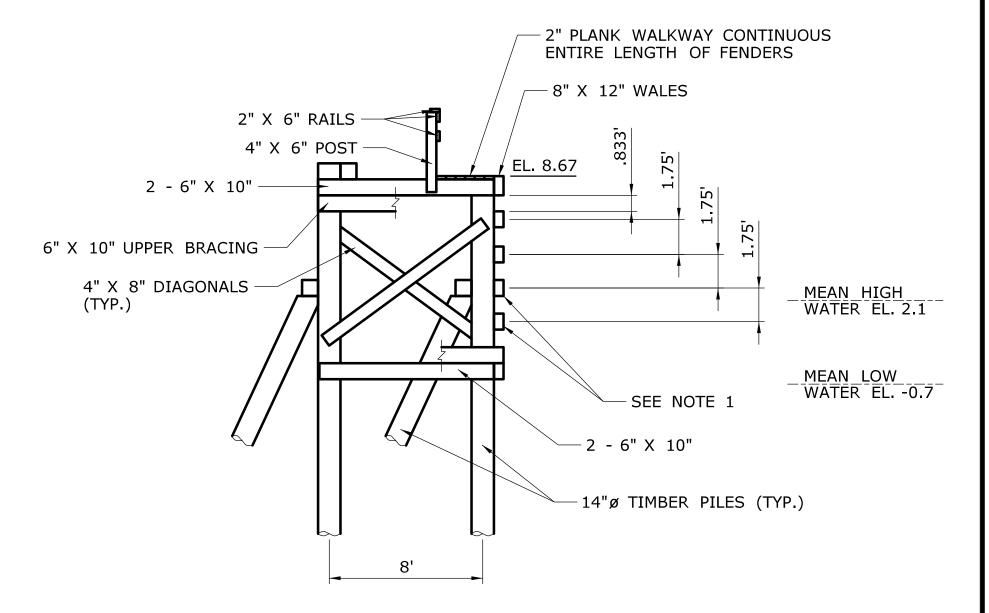
FENDER REPAIR DETAILS
SHEET NO.
05.023 **BRIDGE NO. 03426**

FENDER REPAIR NOTES:

REPAIR PIER FENDERS INCLUDING SPLIT/BROKEN TIMBER WALES AND TIMBER PLATFORM BOARDS WHICH ARE DETACHED AND SOFT. THE BOTTOM TWO WALES (8" BY 12") ALONG THE WATER LINE SHALL BE REPLACED UNLESS DIRECTED OTHERWISE BY THE ENGINEER. REPAIRS SHALL CONSIST OF REPLACEMENT IN KIND AS DIRECTED BY THE ENGINEER AND IN ACCORDANCE WITH THE SPECIAL PROVISION "TIMBER BRIDGE TIES".

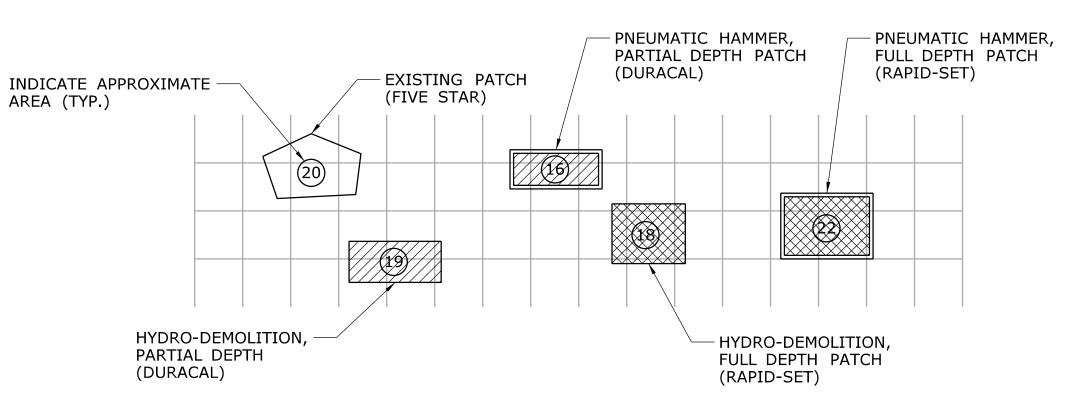
EXAMPLE PLAN

DECK PATCHING LEGEND:

REPLACE WITH FULL DEPTH PATCH.

- 1. THE BEGINNING AND COMPLETION DATES OF REPAIRS.
- 2. THE LIMITS OF EXISTING AND FINISHED PATCHED DECK AREAS ON THE PLAN USING THE PATTERN SHOWN IN THE DECK PATCHING LEGEND. (SEE EXAMPLE PLAN)
- 3. THE APPROXIMATE PERCENTAGE OF TOTAL DECK AREA REPAIRED WITH PARTIAL AND FULL DEPTH PATCHES.
- 4. THE FINAL QUANTITIES OF PARTIAL AND FULL DEPTH PATCHING MATERIALS USED IN THE DECK REPAIRS.
- 5. THE METHOD AND LIMIT OF REMOVAL OF THE DETERIORATED CONCRETE FOR EXAMPLE PNEUMATIC HAMMER OR HYDRO-DEMOLITION AS INDICATED ON THE DECK PLAN.
- 6. THE BRAND OF PATCHING MATERIAL USED AT EACH LOCATION ON THE DECK (DURACAL, CLASS "F" CONCRETE, ETC.) AS SHOWN IN THE EXAMPLE PLAN.

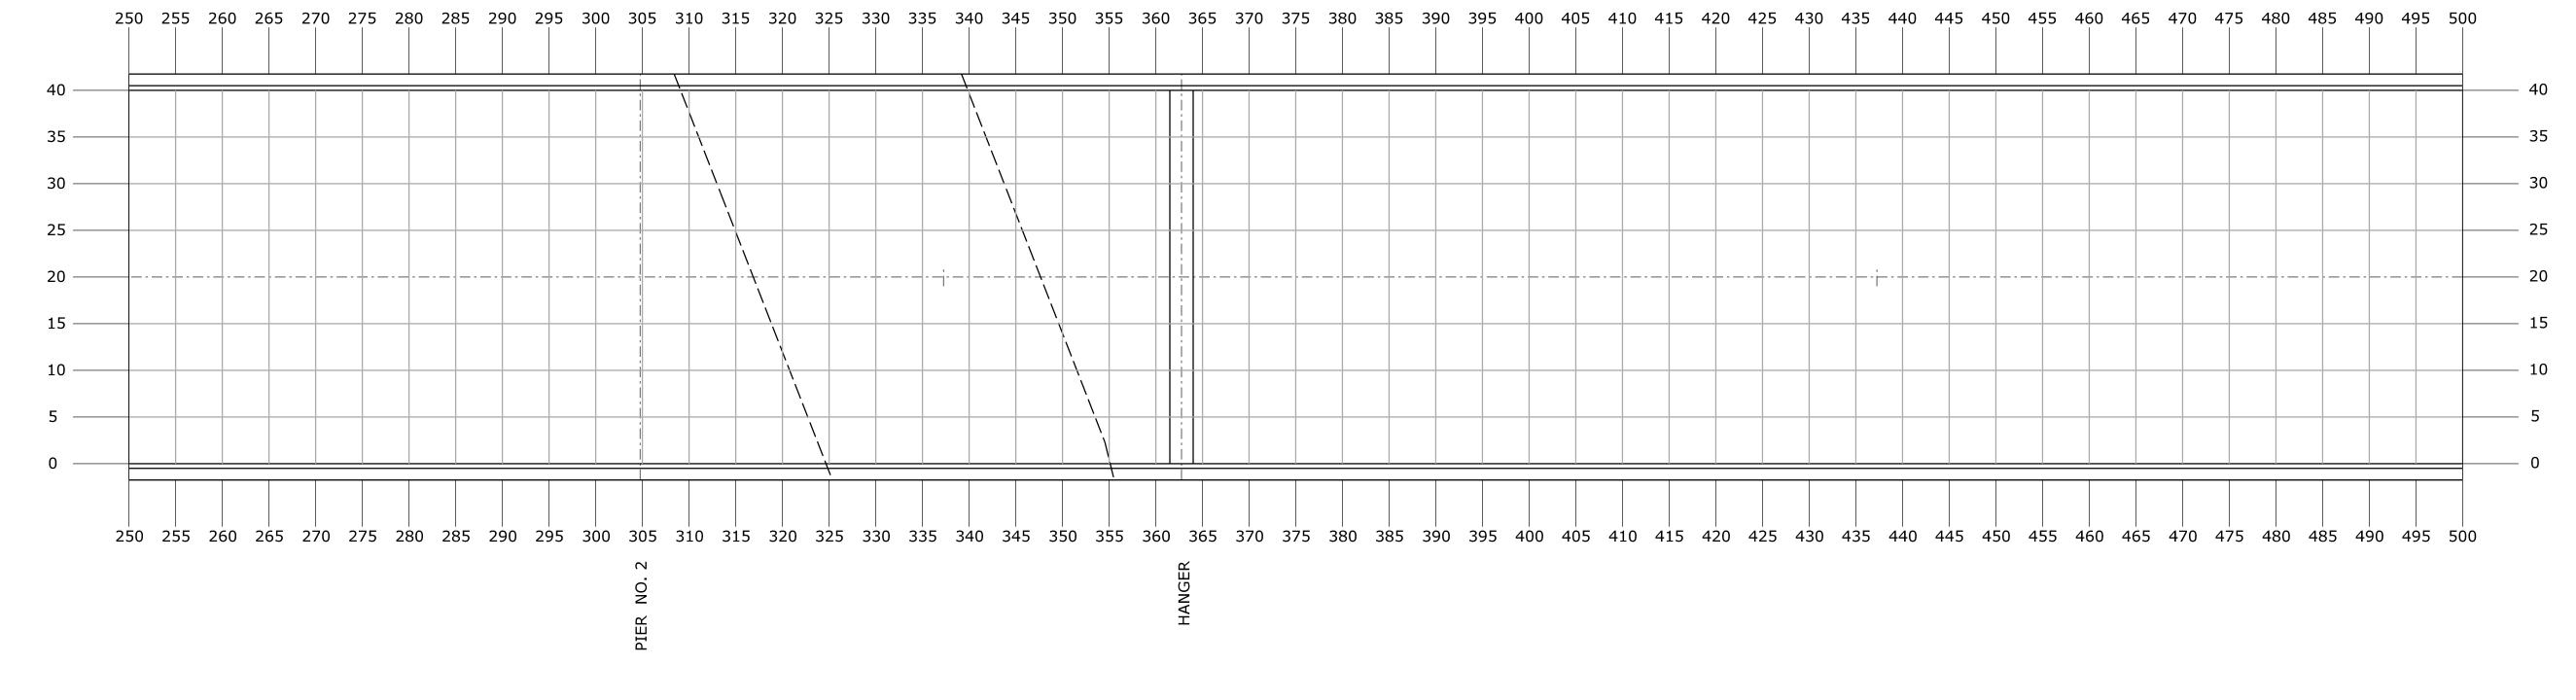
PARTIAL PLAN

- 2. THE LIMITS OF EXISTING AND FINISHED PATCHED DECK AREAS ON THE PLAN USING THE PATTERN SHOWN IN THE DECK PATCHING LEGEND. (SEE EXAMPLE PLAN)
- 3. THE APPROXIMATE PERCENTAGE OF TOTAL DECK AREA REPAIRED WITH PARTIAL AND FULL DEPTH PATCHES.
- 4. THE FINAL QUANTITIES OF PARTIAL AND FULL DEPTH PATCHING MATERIALS USED IN THE DECK REPAIRS.
- 5. THE METHOD AND LIMIT OF REMOVAL OF THE DETERIORATED CONCRETE FOR EXAMPLE PNEUMATIC HAMMER OR HYDRO-DEMOLITION AS INDICATED ON THE DECK PLAN.
- 6. THE BRAND OF PATCHING MATERIAL USED AT EACH LOCATION ON THE DECK (DURACAL, CLASS "F" CONCRETE, ETC.) AS SHOWN IN THE EXAMPLE PLAN.

SCALE: 1'' = 10'
